Inspection Report

Date of Report: May 23, 2007

Mine Name: Tom Taylor
Operator Name: Ziegler Chemical and Mineral

Permit number: S0470065
Inspection Date: April 20, 2007
Time: 9:00 to 9:45 AM

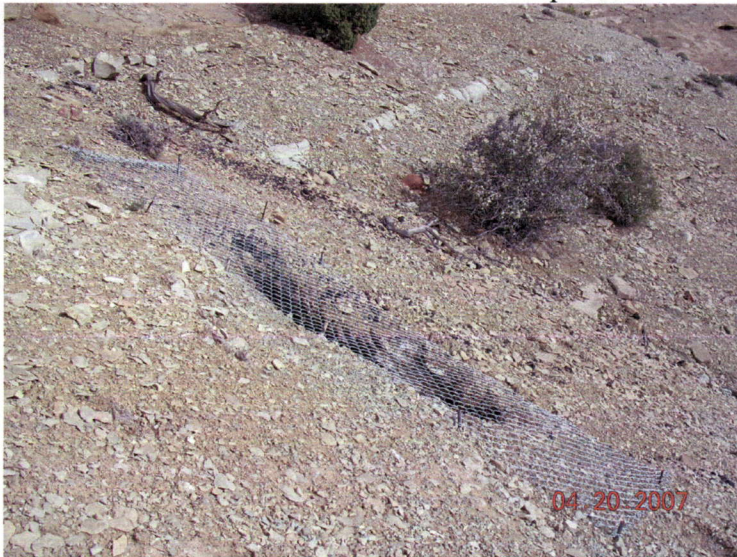
The operator has opened a vent hole (Photo 1) and an escapeway (Photo 2) to the southeast of the mine. These areas are not accessible by vehicle, and it took us about 10 minutes of rough hiking to get to the escapeway.

Photo 1. A vent hole.

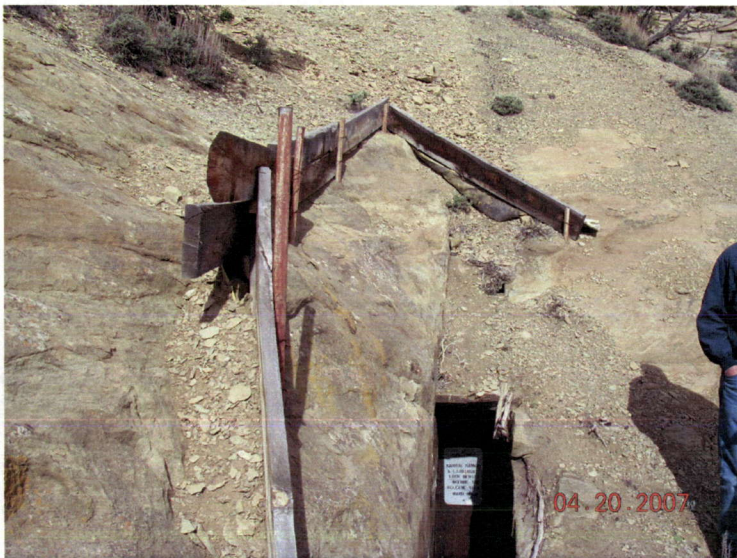
Photo 2. The escapeway.

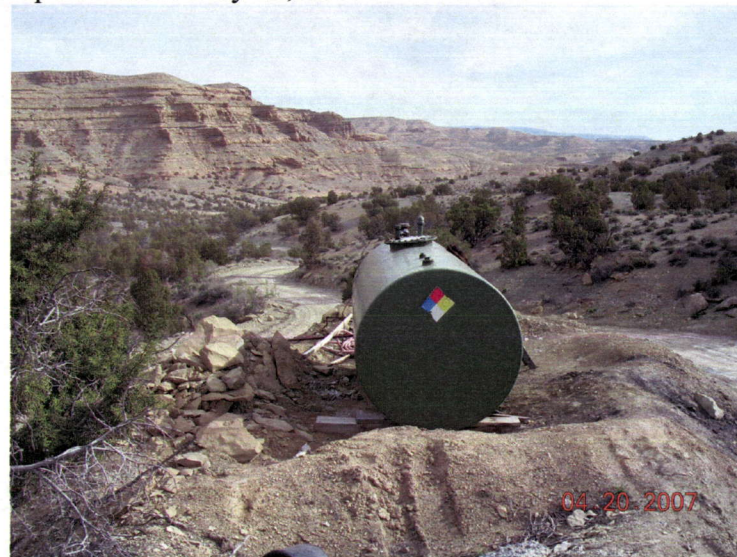
The berm around the fuel tank is such that it would overflow if all the fuel leaked out.

Photo 3. Fuel tank. The berm has some low places where fuel would overflow if the entire contents of the tank were to leak.

The berm around the fuel tank needs to be built up so it could hold all the fuel from the tank with some freeboard. The amount of freeboard is normally 10 percent of the capacity of the tank.

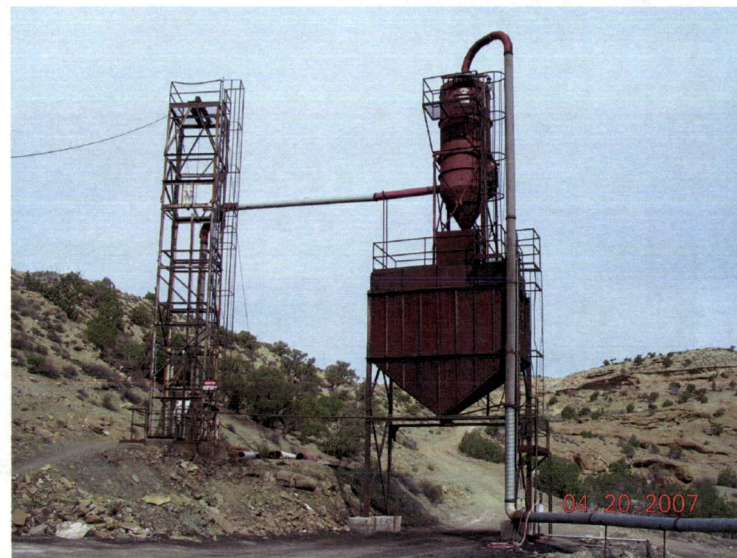
Photo 4. Ore bin and headframe.
